**UPPER PATUXENT RIVER WATERSHED RESTORATION ACTION STRATEGY (WRAS)
FORM 1 -- Catchment Information**

Closest Road Intersection to Outfall: Priest Bridge Road and Espey Court

Site Name: _____ Address: 2145 and 2147 Priest Bridge Road

UPPER PATUXENT RIVER WATERSHED RESTORATION ACTION STRATEGY (WRAS) FORM 3 -- Opportunities and Constraints of Potential Management Practice

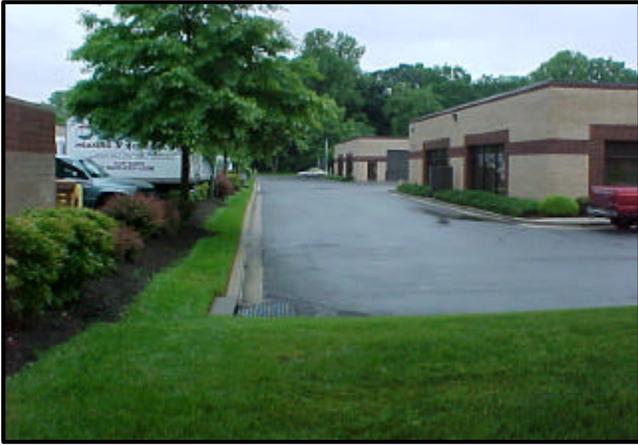
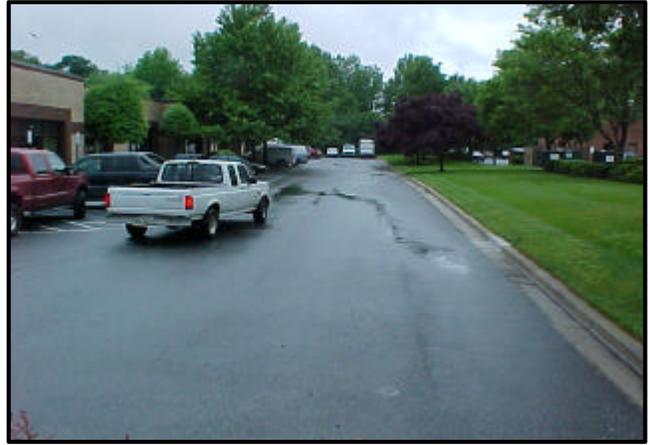
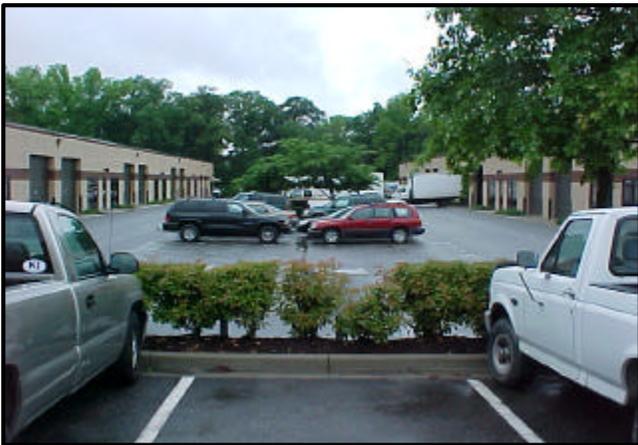
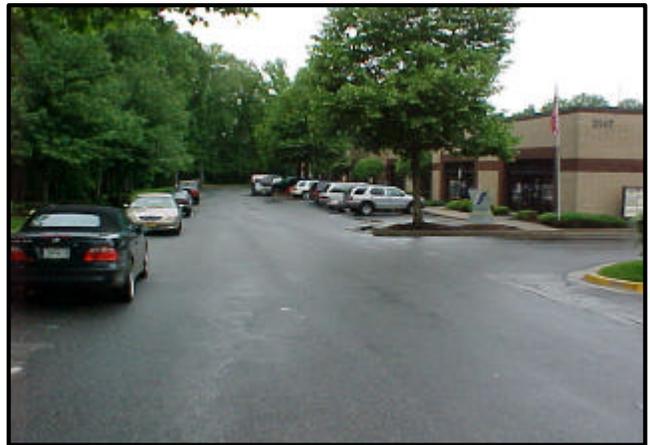
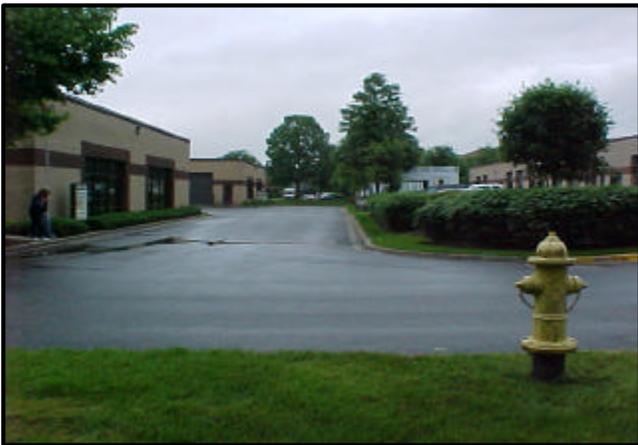
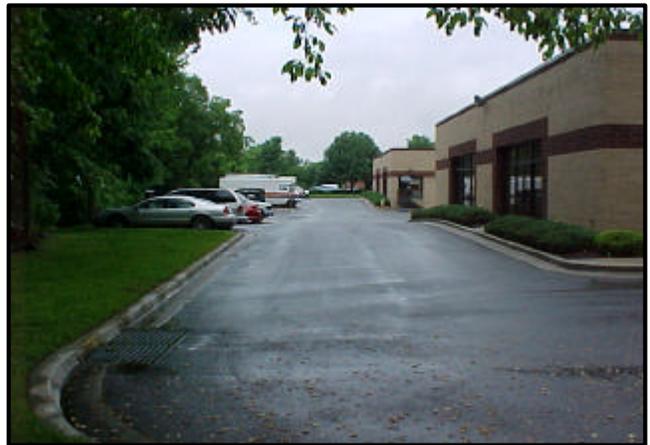
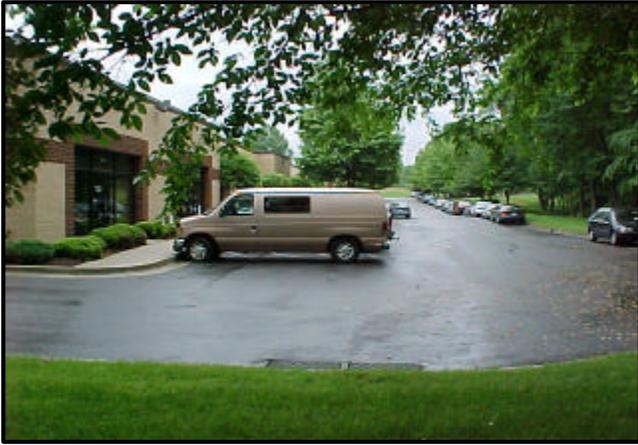
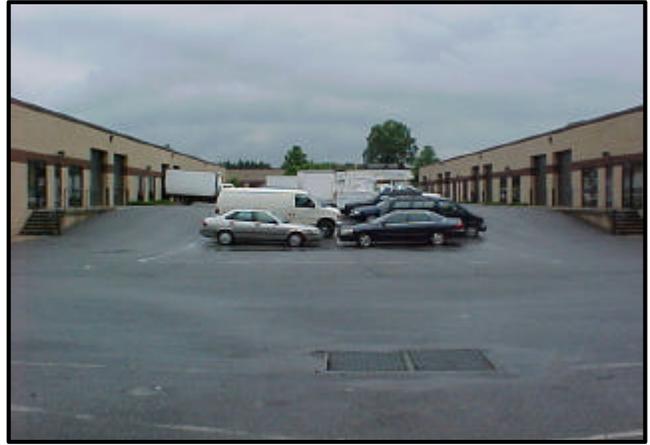
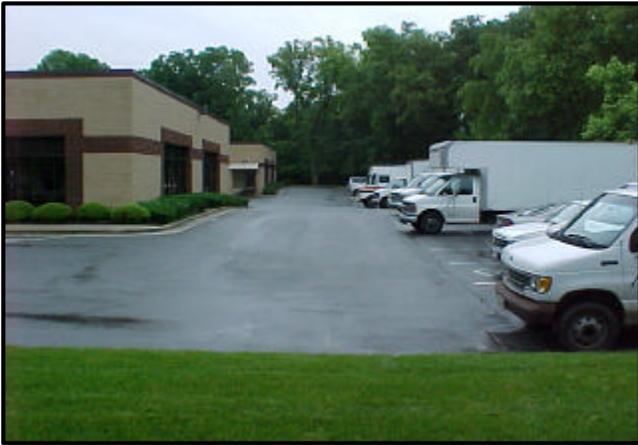
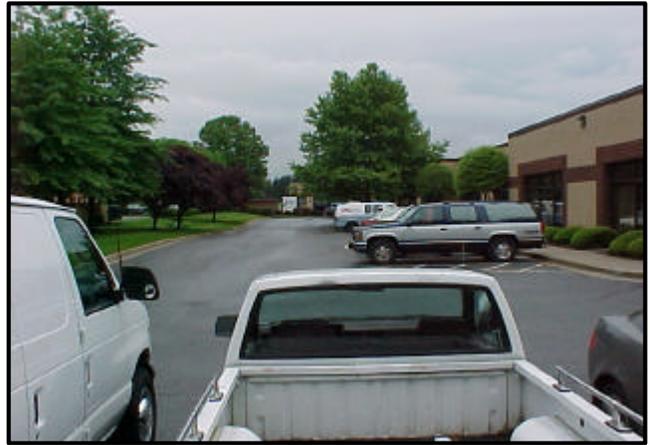
No. <u>144</u>	Description: <u>looking south along east side of property</u>
No. <u>145</u>	Description: <u>looking west along north side of property</u>
No. <u>146</u>	Description: <u>looking west between buildings</u>
No. <u>147</u>	Description: <u>looking west along south side of property</u>
No. <u>148</u>	Description: <u>looking north along east side of property</u>
No. <u>149</u>	Description: <u>looking north along west side of property</u>
No. <u>150</u>	Description: <u>looking east along south side of property</u>
No. <u>151</u>	Description: <u>looking east between buildings</u>
No. <u>152</u>	Description: <u>looking south along west side of property</u>
No. <u>153</u>	Description: <u>looking east along north side of property</u>

Comments Parking is limited, which restricts paved area to be converted from parking. South side of 2147 is very restricted. Commercial between 2145 and 2147 is reserved for fleet parking and employees. There is a great deal of truck traffic.

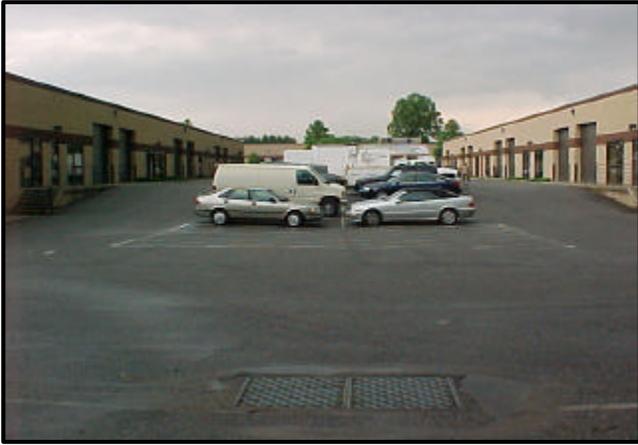
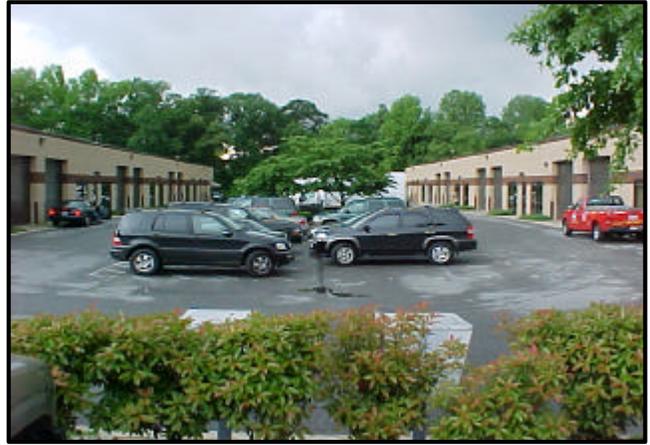
No. <u>171</u>	Description: <u>looking east</u>
No. <u>159</u>	Description: <u>looking west</u>
No. _____	Description: _____

Comments Parking spaces are at a premium. Access is needed to the loading docks.
Previous island is located between "2a" and "2b". The area cannot be used because of
electrical transformer and telephone junction.
Location of IMPs:
2a: X=1397909, Y=481213
2b: X=1398047, Y=481265
IMP/BMP Summary shows combined results for 2a and 2b.
IMP size = 9,360 sq ft

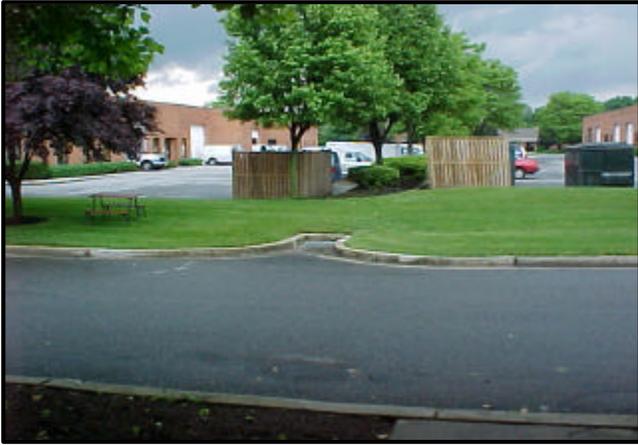
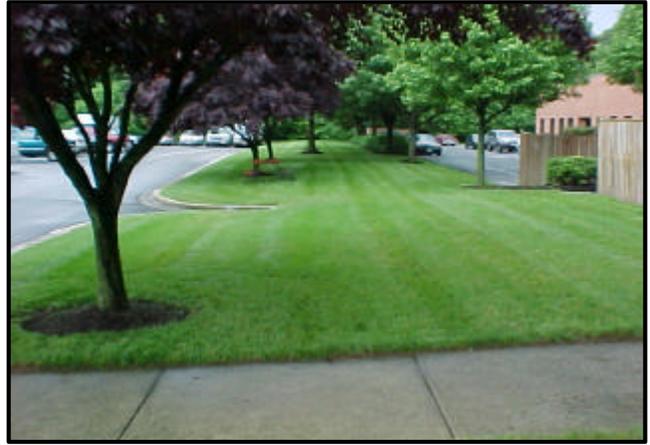
No. <u>154</u>	Description: <u>looking north</u>
No. <u>155</u>	Description: <u>looking west</u>
No. _____	Description: _____

Comments Configure bioretention area to minimize disturbance to trees.
IMP size = 1,323 sq ft

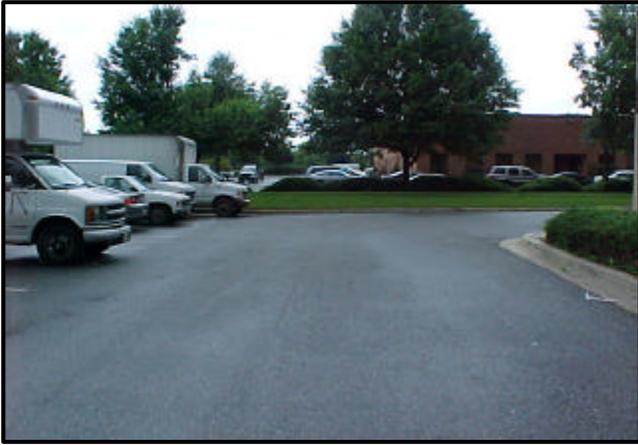
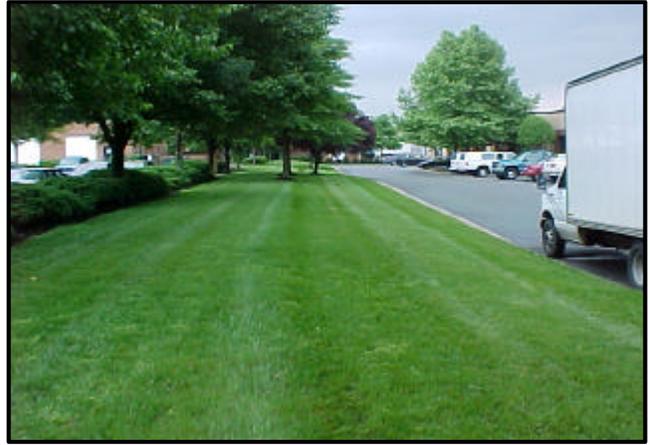
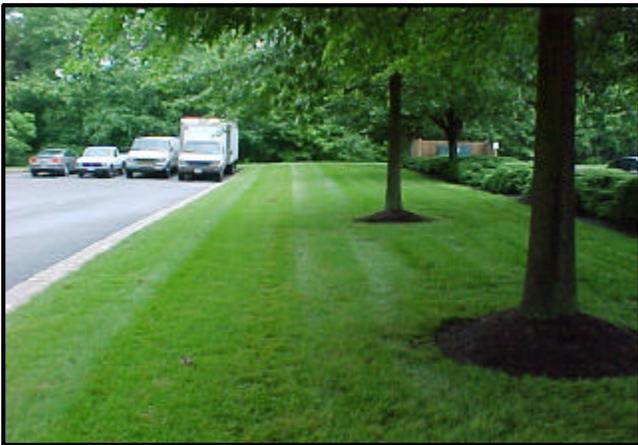
No. <u>174</u>	Description: <u>looking north</u>
No. <u>175</u>	Description: <u>looking east</u>
No. <u>176</u>	Description: <u>looking west</u>
No. _____	Description: _____

Comments Configure bioretention area to minimize disturbance to trees.
IMP size = 1,189 sq ft

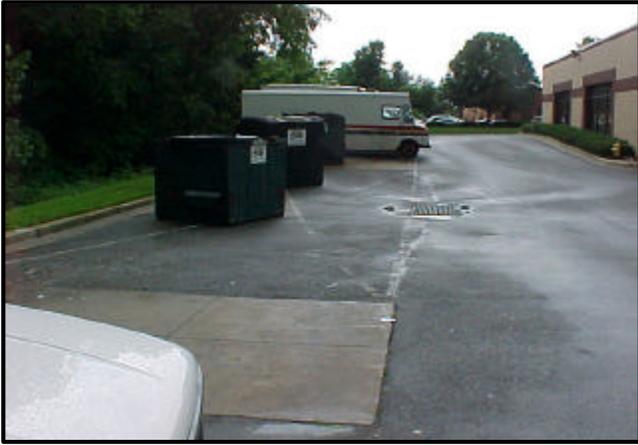
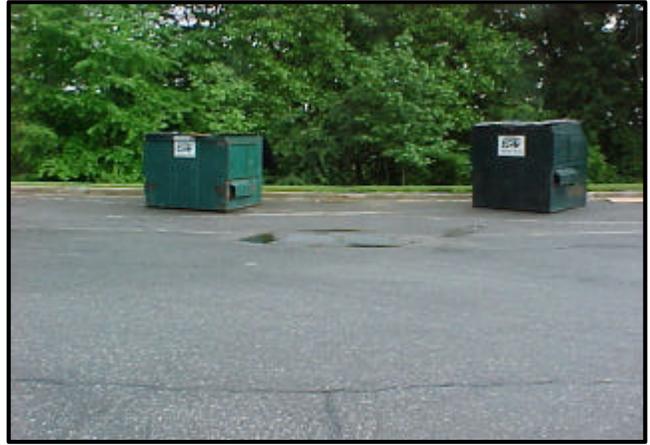
No. <u>172</u>	Description: <u>looking north</u>
No. <u>173</u>	Description: <u>looking west</u>
No. _____	Description: _____

Comments Area to be converted is used as dumpster sotrage and is marked off so as not to be used for parking. Maximum bioretention area is equivalent to 5 parking spots.
Bioretention area provides 87% treatment as sized.
IMP size = 960 sq ft

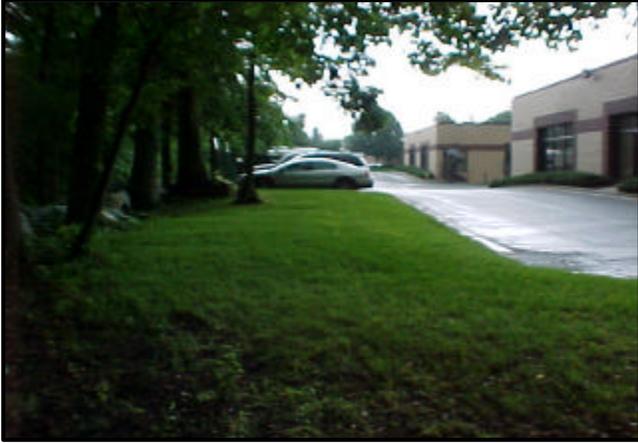
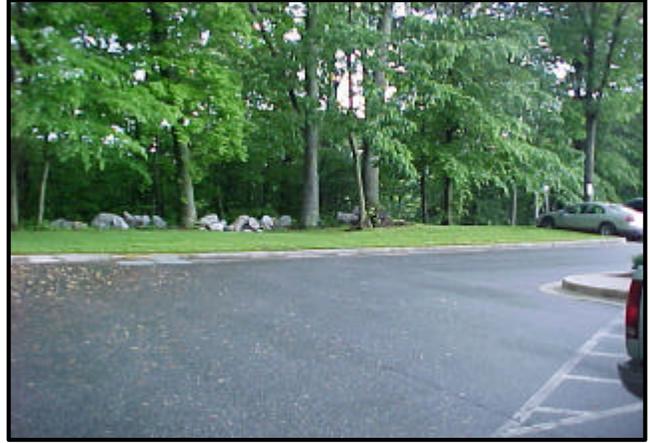
Comments Configure bioretention area to minimize disturbance to existing trees and their root systems. One parking area could be converted if needed.
Bioretention area provides 140% treatment as sized.
IMP size = 723 sq ft

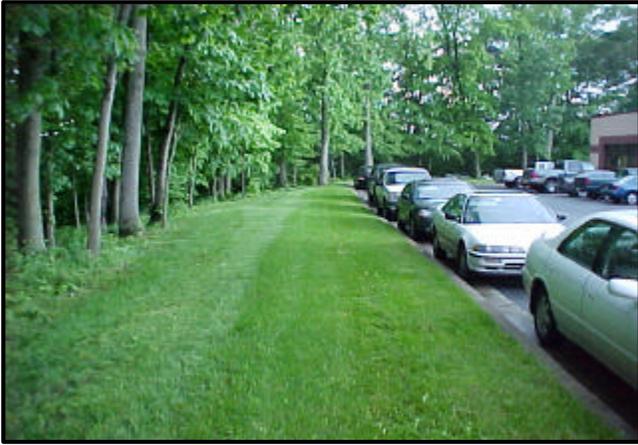
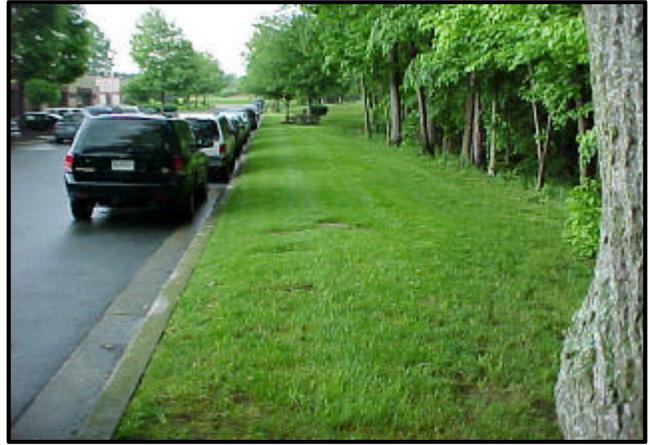
Comments Configure bioretention area to minimize disturbance to trees.
IMP size = 1,189 sq ft

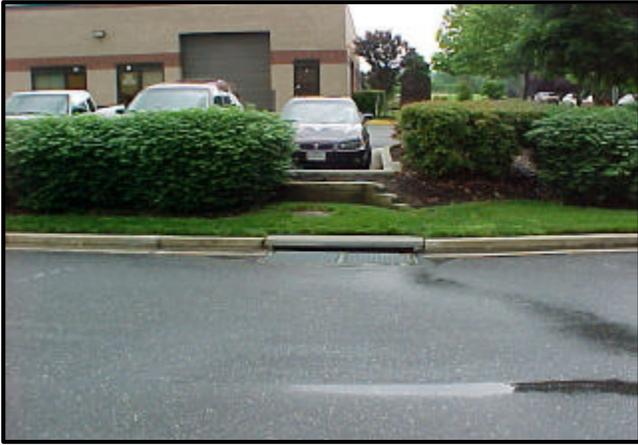
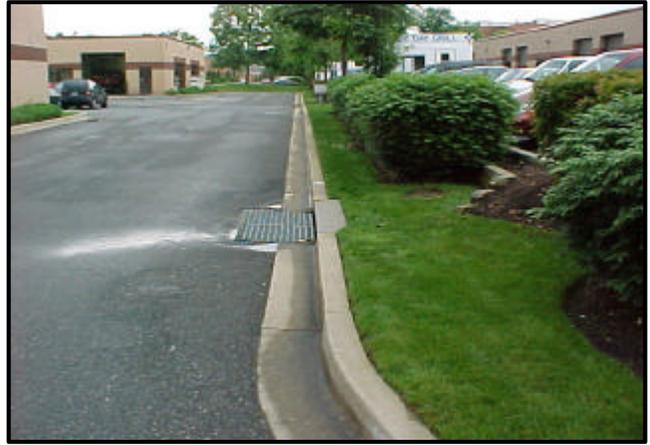
Comments Island cannot be used for bioretention because Site 31 is higher.
IMP/BMP Summary assumes 100% treatment from Filterra (to be sized).

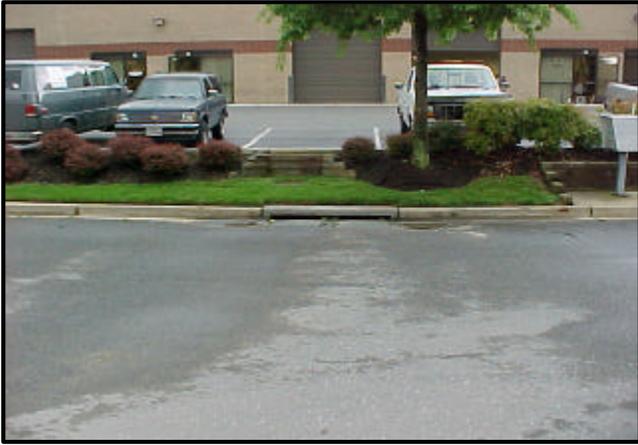
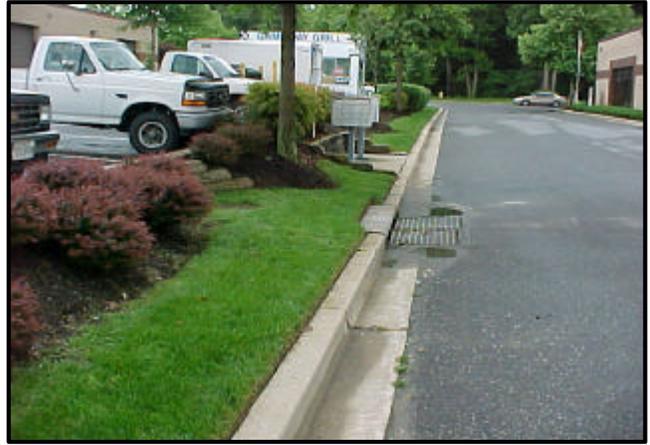
Comments Island cannot be used for bioretention because Site 31 is higher.
IMP/BMP Summary assumes 100% treatment from Filterra (to be sized).

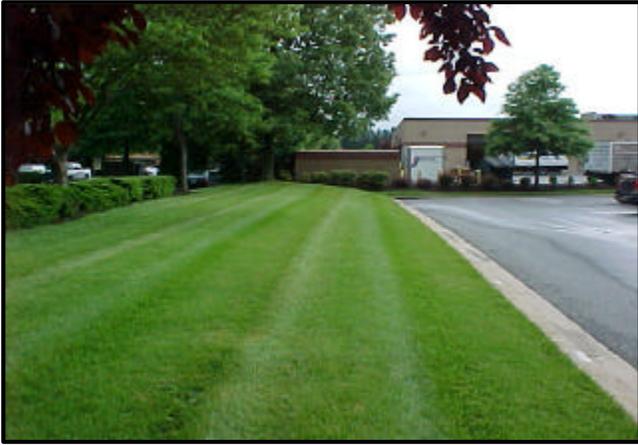
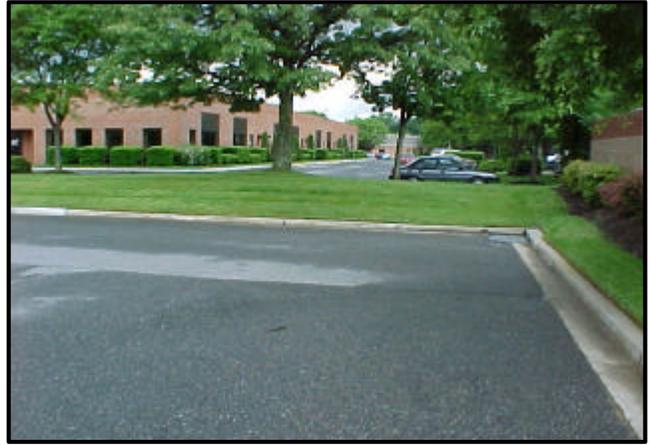
Comments Configure bioretention area to minimize disturbance to trees.
IMP size = 849 sq ft

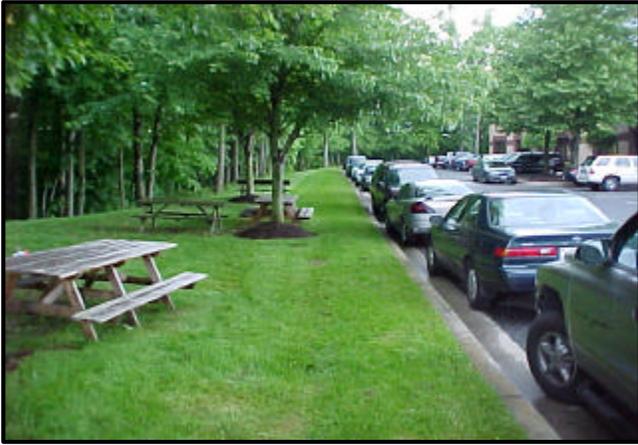
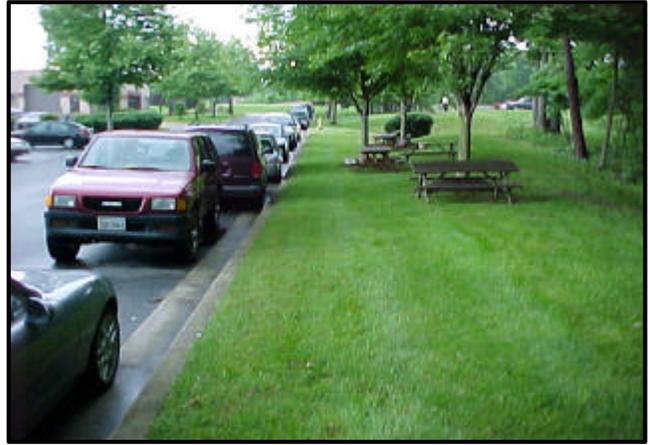
Comments Configure bioretention area to minimize disturbance to trees.
IMP size = 2,0592 sq ft
